# VEHICLE INSPECTION REPORT

**WS19AAV**

## Fiat Ducato 35 2.3 II MULTIJET 130PS

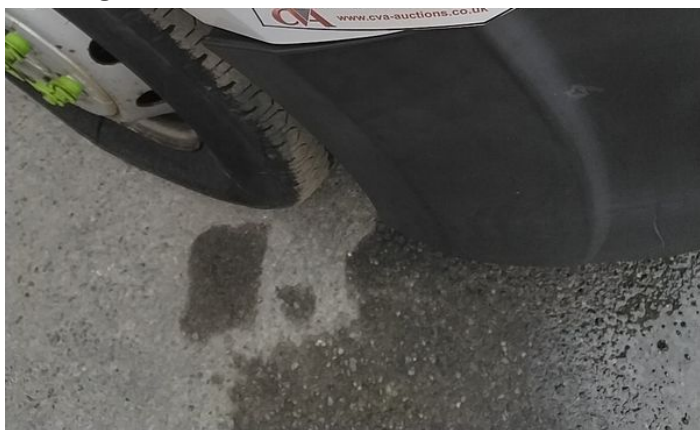
1: Wing osf  
Scratched  
Over 25mm Thru Paint

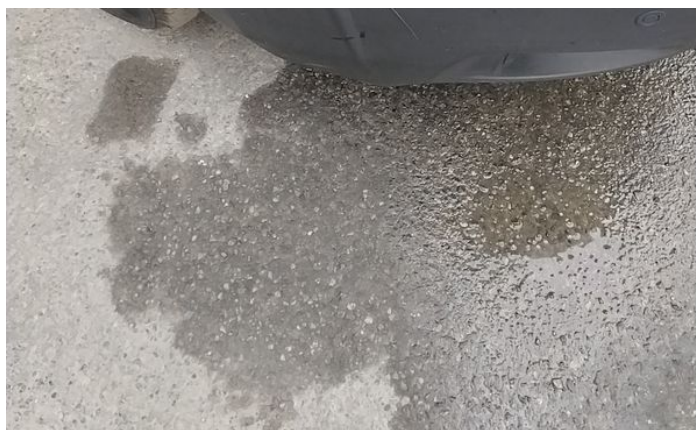
2: Bumper Front  
Scratched  
Over 100mm Thru Paint

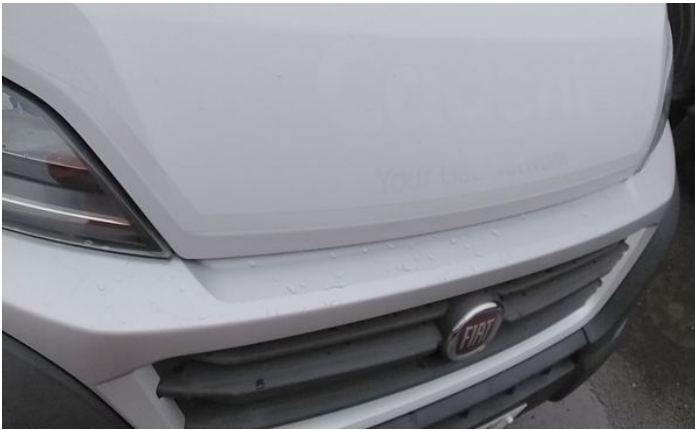
3: Bonnet  
Chipped  
Multiple Chips

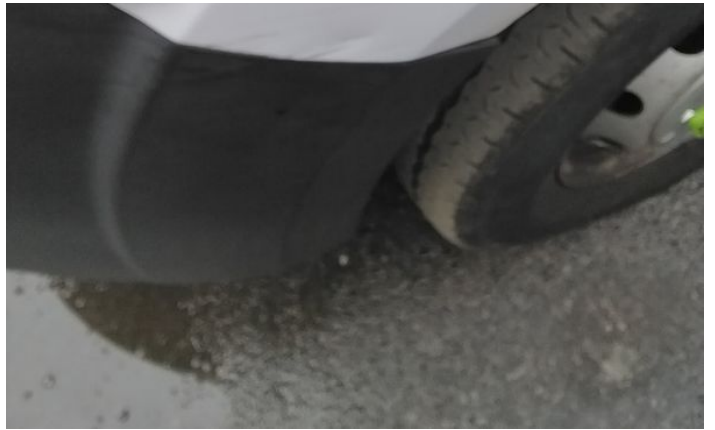
4: Wing nsf  
Dented  
With Paint Damage

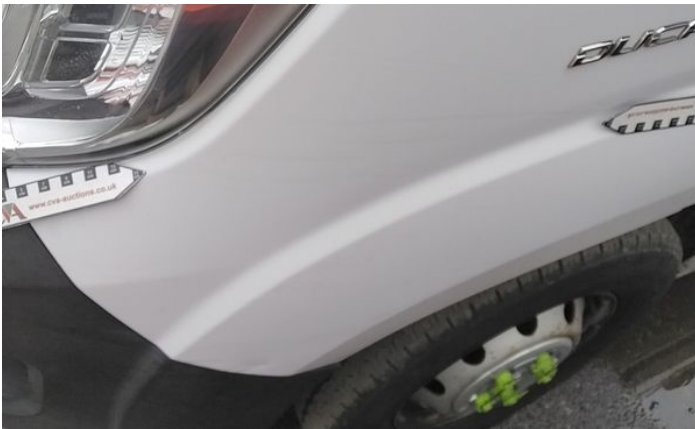
5: Wing nsf  
Scratched  
Over 25mm Thru Paint

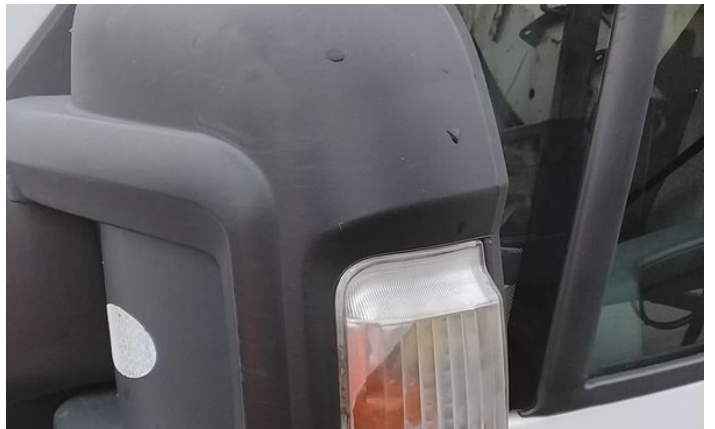
6: Door Mirror Assy nsf  
Scuffed (Unpainted)  
Over 100mm

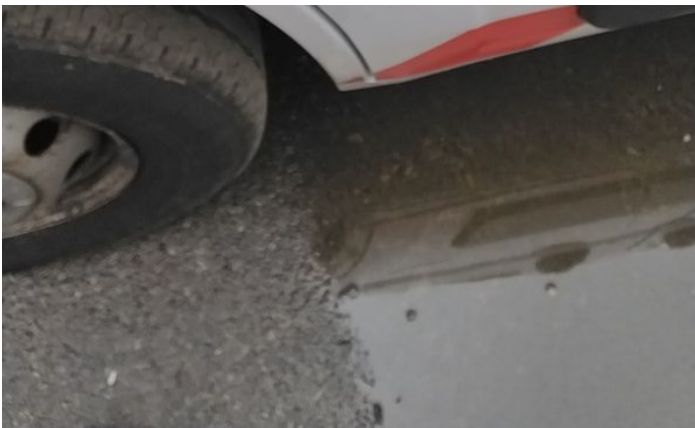
7: Door nsf  
Dented  
Over 30mm

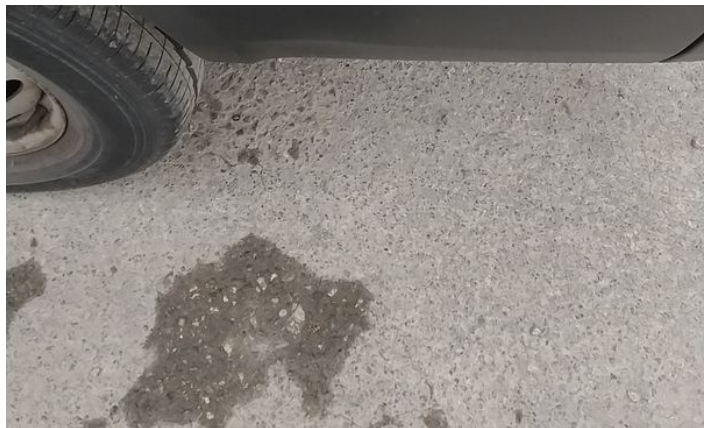
8: Qtr Panel Moulding ns  
Scuffed (Unpainted)  
UpTo 100mm

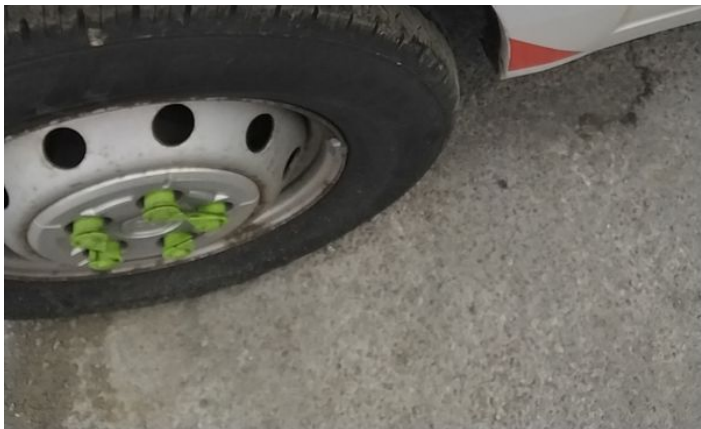
9: Qtr Panel osr  
Dented  
Over 30mm

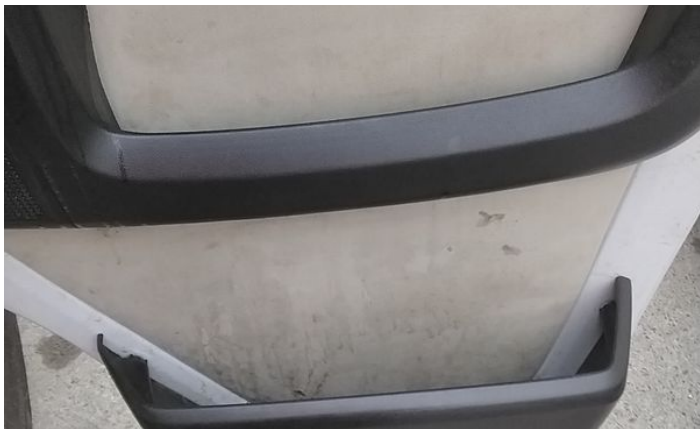
10: Door Pad osf  
Soiled  
Heavy

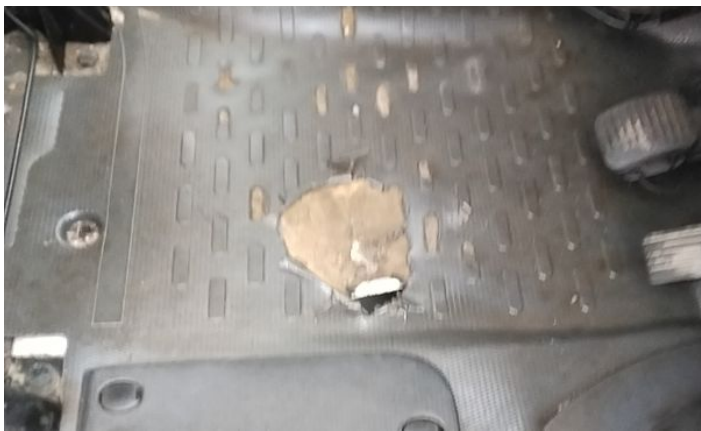
11: Carpets Front  
Holed  
Over 3mm

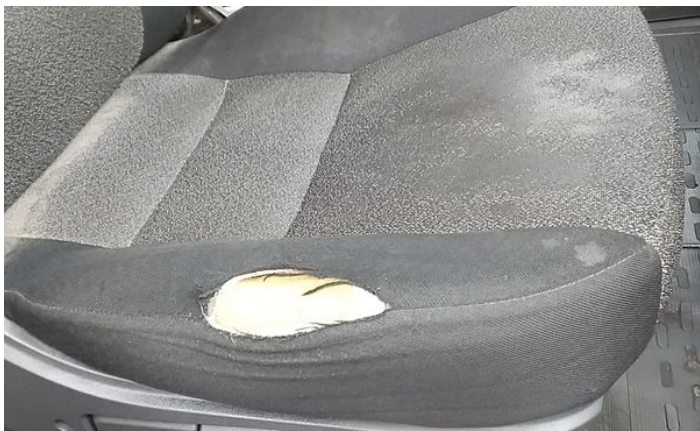
12: Seat Base Cover osf  
Holed  
Over 3mm
